The Road Inventory of Camas National Wildlife Refuge Hamer, ID

Prepared By:
Federal Highway Administration
Central Federal Lands Highway Division
April 2013

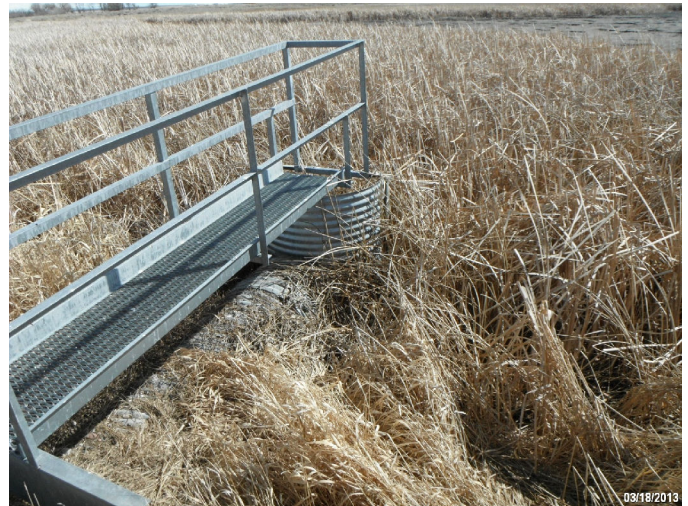
Photo: CAMA_C4_0482 Route: 010-001-0.58
Metal WCS Flashboard Riser 40ft long 24in dia. 2ft deep

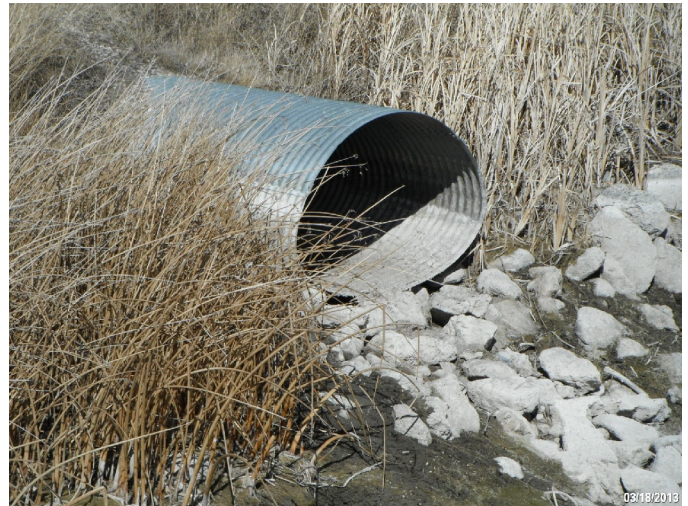
Photo: CAMA_C4_0488 Route: 010-002-1.7
Metal WCS Flashboard Riser 50ft long 48in dia. 3ft deep

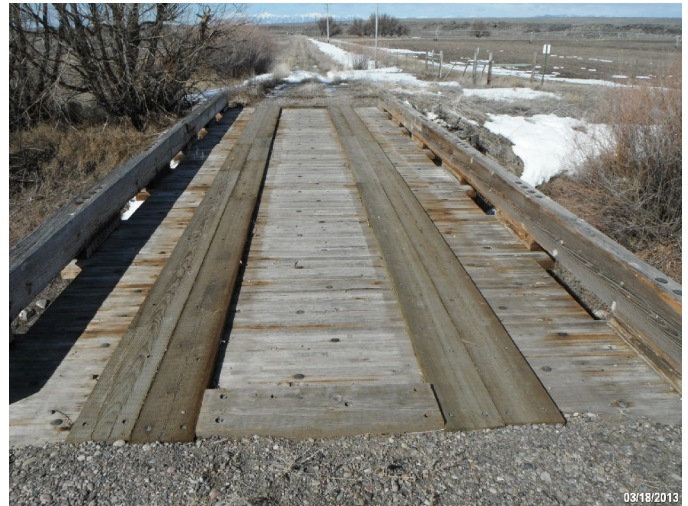
Photo: CAMA_C4_0443 Route: 403-001-0.0
Begin Section

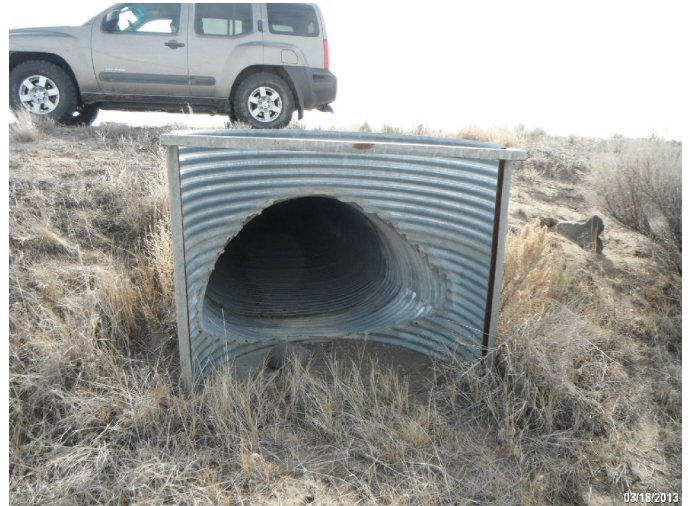
Photo: CAMA_C4_0451 Route: 404-001-0.0
Begin Section

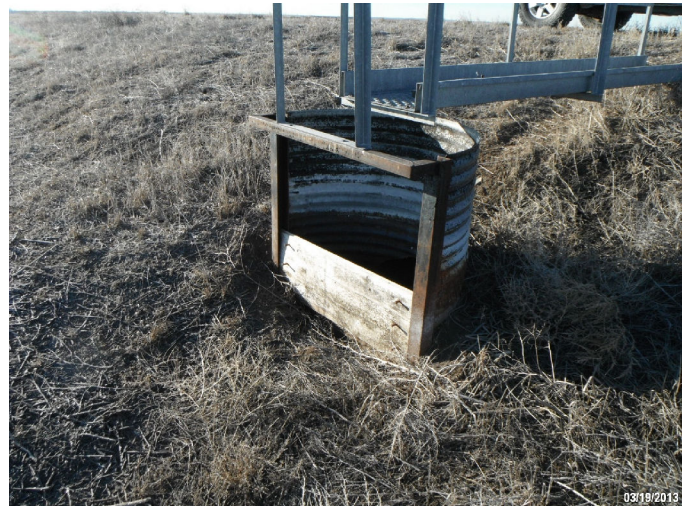
Photo: CAMA_C4_0565 Route: 409-001-0.0
Begin Section

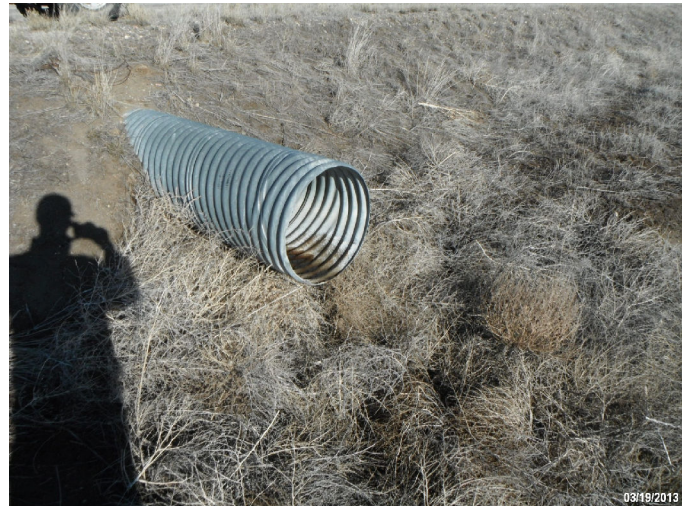
Photo: CAMA_C4_0592 Route: 411-003-1.83
Begin Section

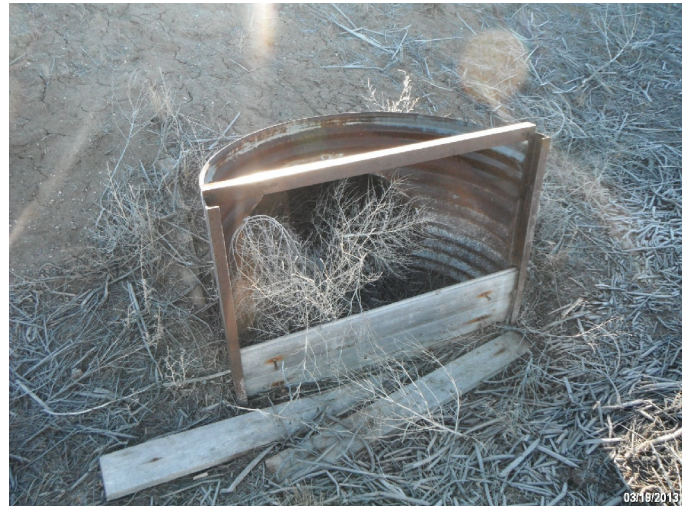
Photo: CAMA_C4_0589 Route: 411-003-1.91
Metal WCS Flashboard Riser 20ft long 24in dia. 3ft deep

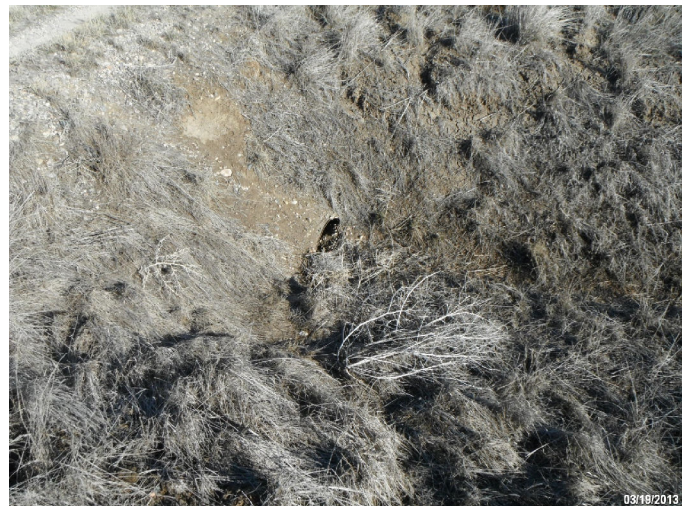
Photo: CAMA_C4_0587 Route: 411-003-2.41
Metal WCS Flashboard Riser 20ft long 36in dia. 3ft deep
